Pre-Purchase Inspection - Residential Building Report

Complies with Australian Standard AS 4349.1- 2007 Inspection of Buildings Part 1: Pre-Purchase inspections – Residential buildings – Appendix “C”

Inspection Address: Kirwan

Date of the Inspection: 08-March-2017 **Time of Inspection:** 3:00:00 PM

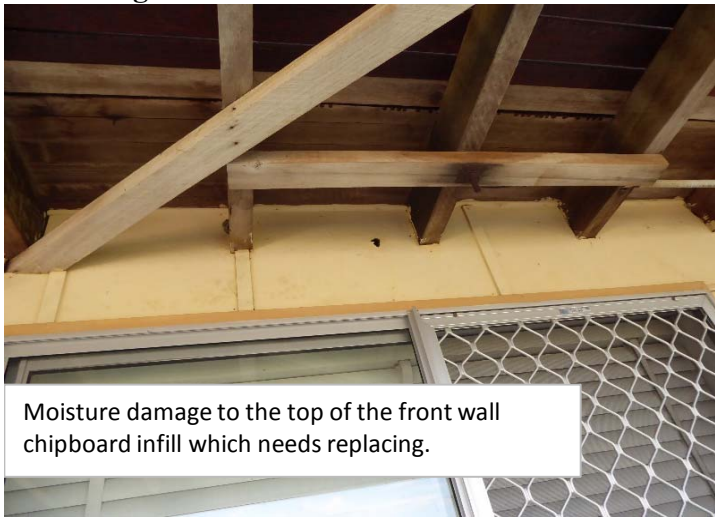
Moisture damage to the top of the front wall chipboard infill which needs replacing.

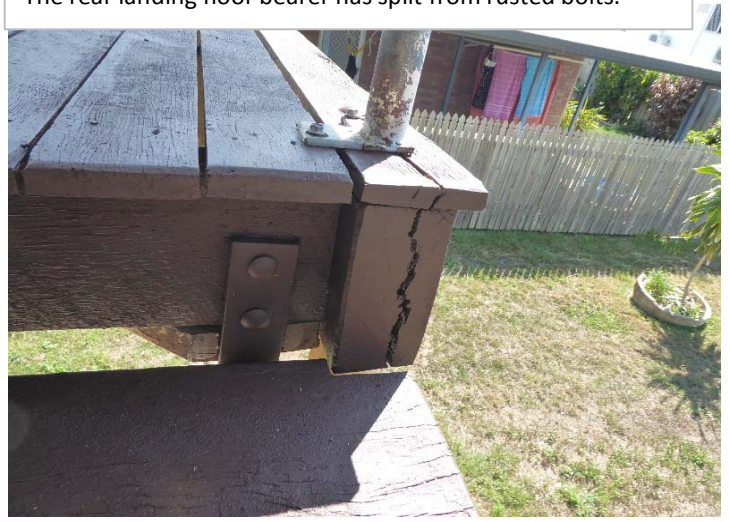
The rear landing floor bearer has split from rusted bolts.

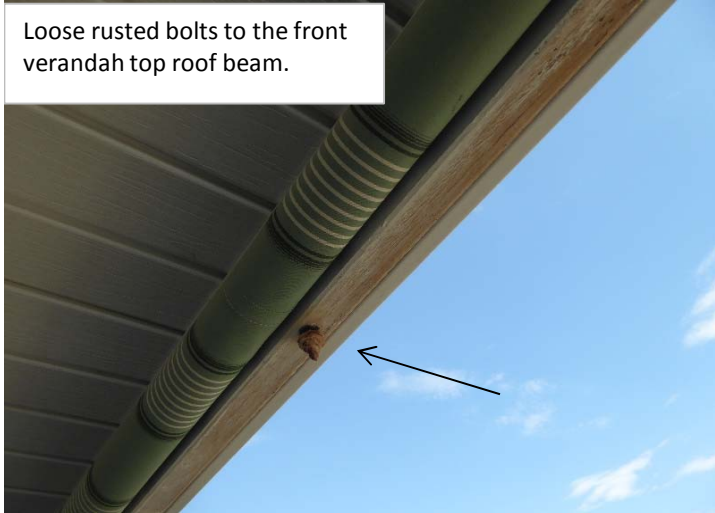
Loose rusted bolts to the front verandah top roof beam.

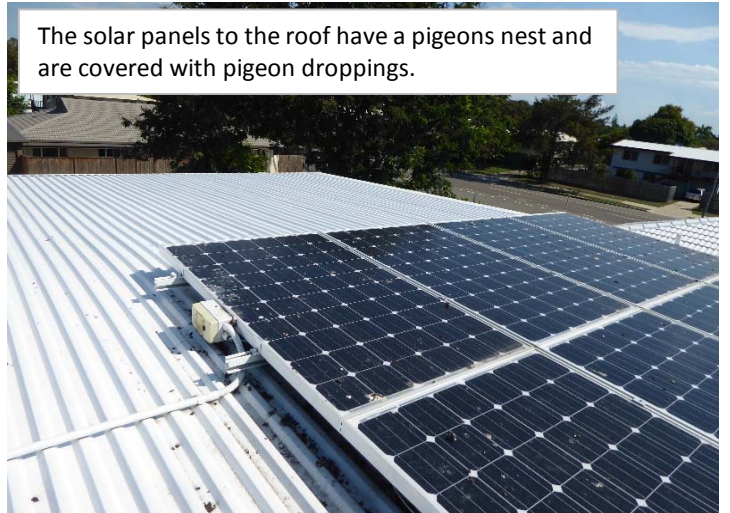
The solar panels to the roof have a pigeons nest and are covered with pigeon droppings.

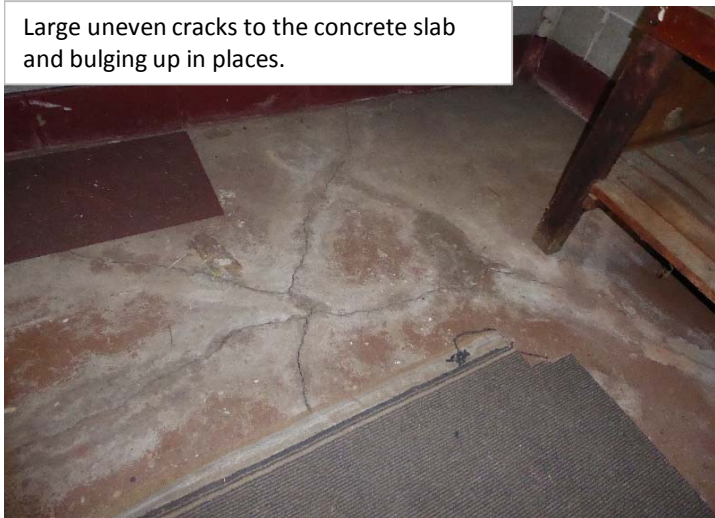
Large uneven cracks to the concrete slab and bulging up in places.

Recommendations: It is recommended that a licensed builder inspect the concrete floor, the pier bracing and the cyclone bolts, report on the scope of work required to repair or rectify the defects and quote a price for this work.

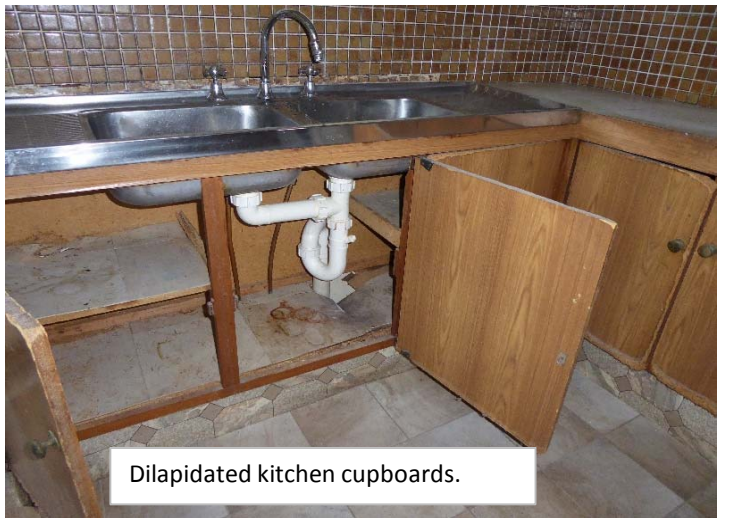
Dilapidated kitchen cupboards.

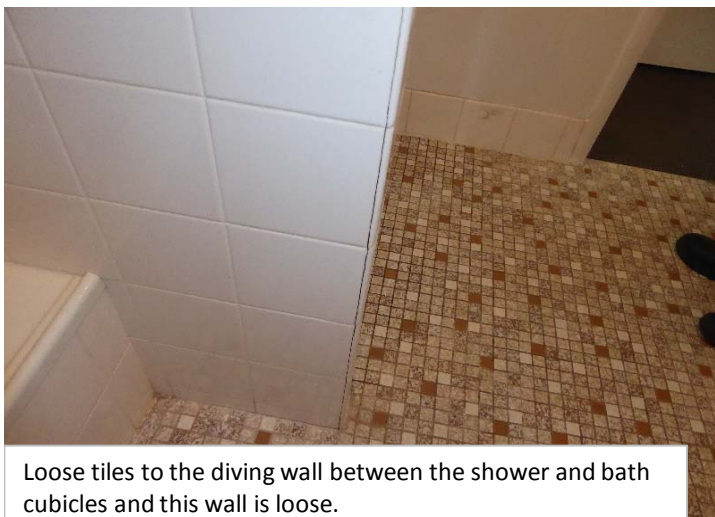
Loose tiles to the diving wall between the shower and bath cubicles and this wall is loose.

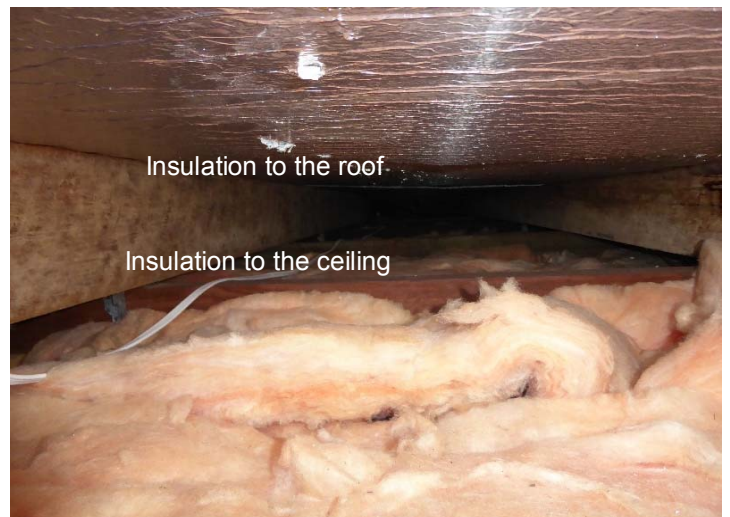
Insulation to the roof

Insulation to the ceiling
