Pre-Purchase Inspection - Residential Building Report

Clients Name: Low Set Masonry Block Home

Inspection Address: Annandale

Date of the Inspection: 12-August-2017 **Time of Inspection:** 12:30:00 PM

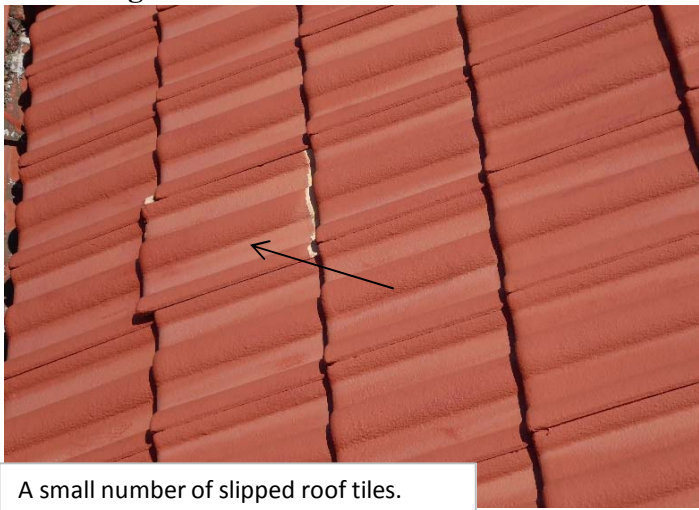
A small number of slipped roof tiles.

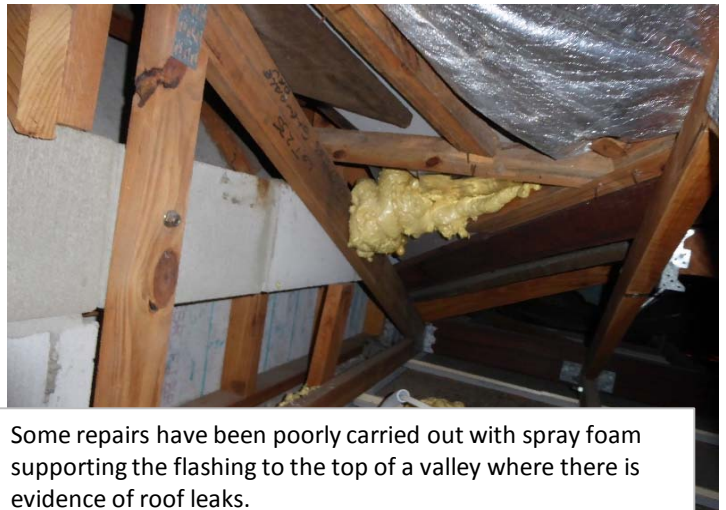
Roof , Valleys	Some repairs have been poorly carried out with spray foam supporting the flashing to the top of a valley where there is evidence of roof leaks. The front roof valleys have recently been repaired which is likely the result of roof leaks. There are a small number of slipped roof tiles which need refixing. Repairs are required. It is recommended that a licensed roof tiler inspect the roof, report on the scope of work required to repair or rectify the defects and quote a price for this work.
Guttering Down Pipes	The guttering needs resealing to the joins.
Eaves & Gablends	There is a small amount of moisture damage to the eaves to the L/H side of the front entry caused from either a roof leak or the guttering leaking. The eaves sheet is cracked to this area. Rot to the front gable decorative moulding.
Facias & Barges	✓

Some repairs have been poorly carried out with spray foam supporting the flashing to the top of a valley where there is evidence of roof leaks.

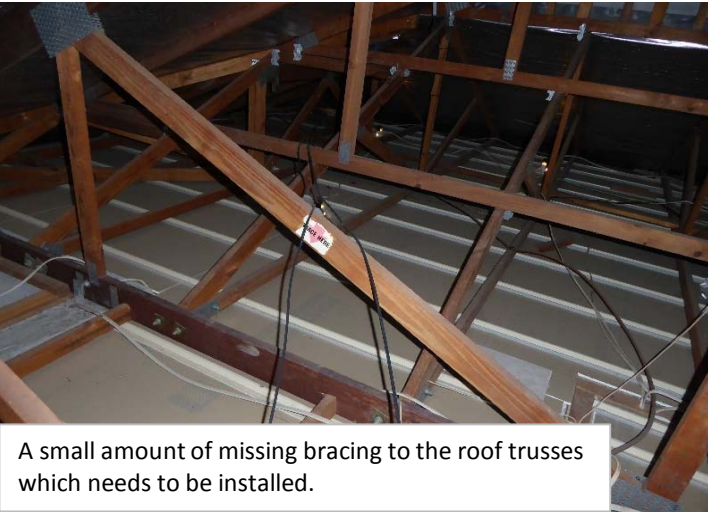
A small amount of missing bracing to the roof trusses which needs to be installed.

Roof Frame	A small amount of missing bracing to the roof trusses which needs to be installed. It is recommended that a licensed carpenter inspect the roof frame and carry out necessary rectification work.
Roof Covering	Not visible. Covered by insulation.
Insulation & Sarking	There is sarking aluminium foil insulation to the roof of this property.
Party Walls	N/A

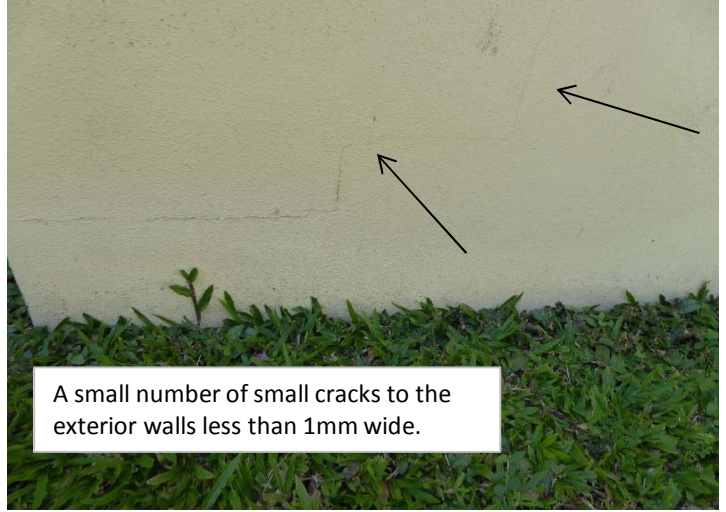
A small number of small cracks to the exterior walls less than 1mm wide.

2.0 EXTERIOR OF THE BUILDING	
Walls	A small number of small cracks to the exterior walls less than 1mm wide.
Exterior Paint	The exterior wall cracks will need to be filled with acrylic or polyurethane based joint sealant filler to prevent moisture penetrating into the walls. A small amount of peeling paint to the front living room window sill.
Doors	✓
Windows	✓
Verandahs, Patios, Decks,	A cracked tile to the front patio floor.
Window Sills	N/A
Attached Structures	N/A

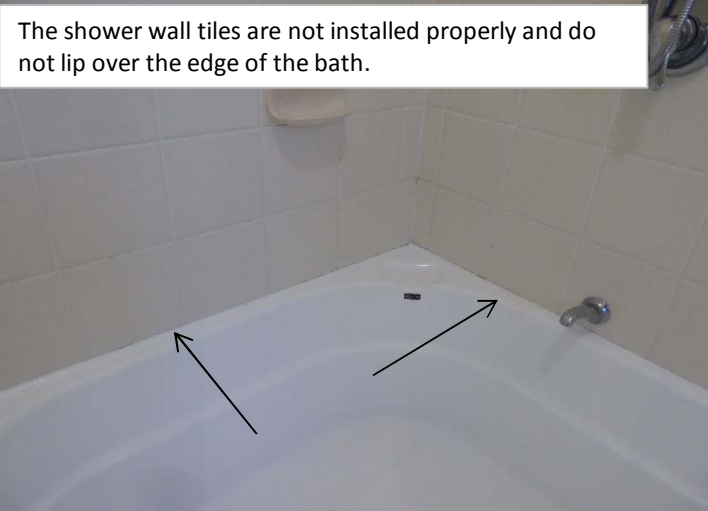
The shower wall tiles are not installed properly and do not lip over the edge of the bath.

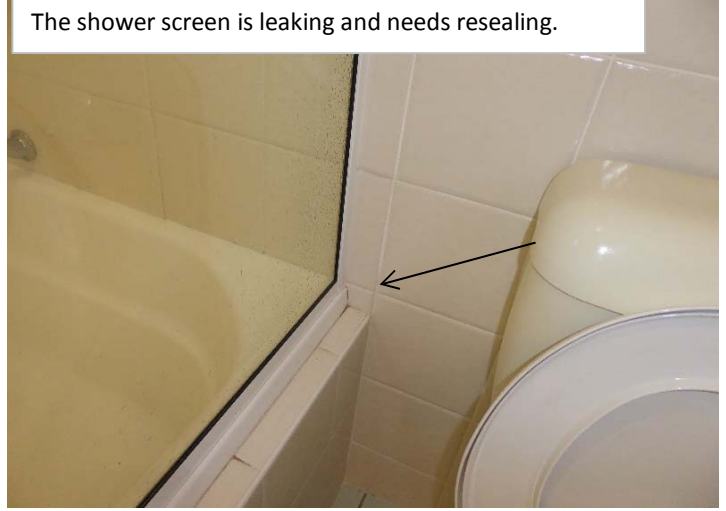
The shower screen is leaking and needs resealing.

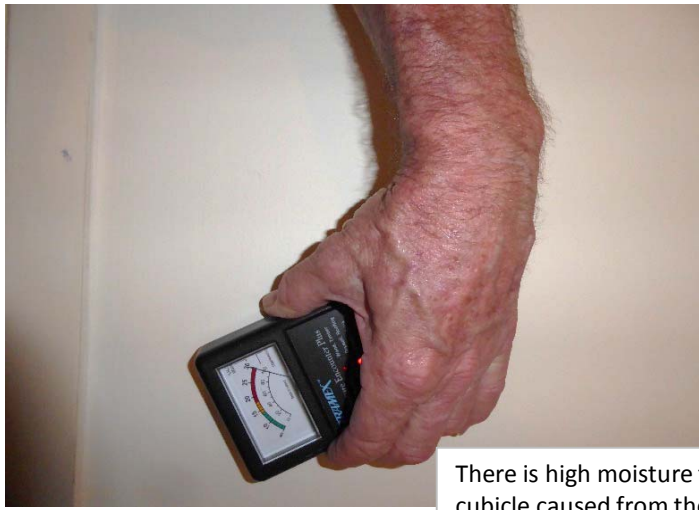
There is high moisture to the bedroom wall adjacent to the ensuite shower cubicle caused from the shower leaking into the wall.
