Pre-Purchase Inspection - Residential Building Report

Complies with Australian Standard AS 4349.1- 2007 Inspection of Buildings Part 1: Pre-Purchase inspections – Residential buildings – Appendix “C”

Clients Name: Low Set Masonry Block Home

Inspection Address: Kirwan

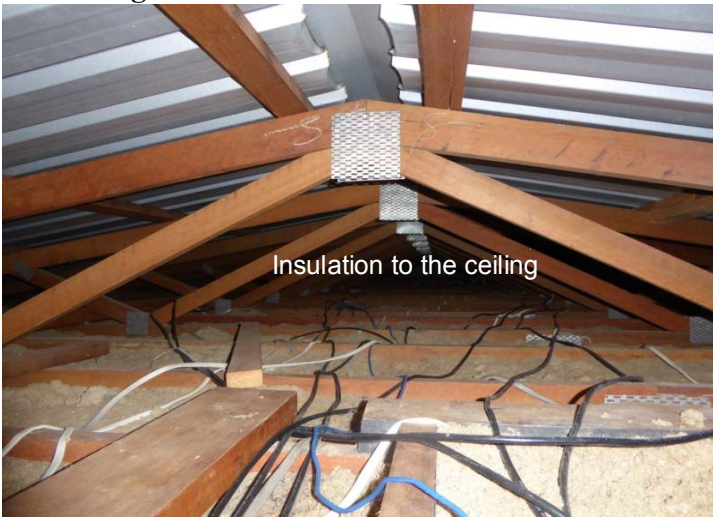
Insulation to the ceiling

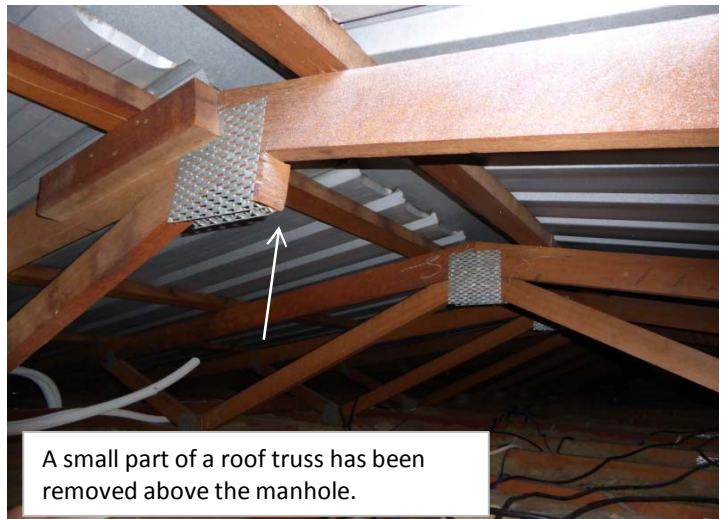
Roof Frame	A small part of a roof truss has been removed above the manhole. Minor repairs are required to the truss. There is limited access to the roof interior and the roof space was only viewed from the manhole.
Roof Covering	✓
Insulation & Sarking	There are insulation batts to the ceiling of this property.
Party Walls	N/A

A small part of a roof truss has been removed above the manhole.

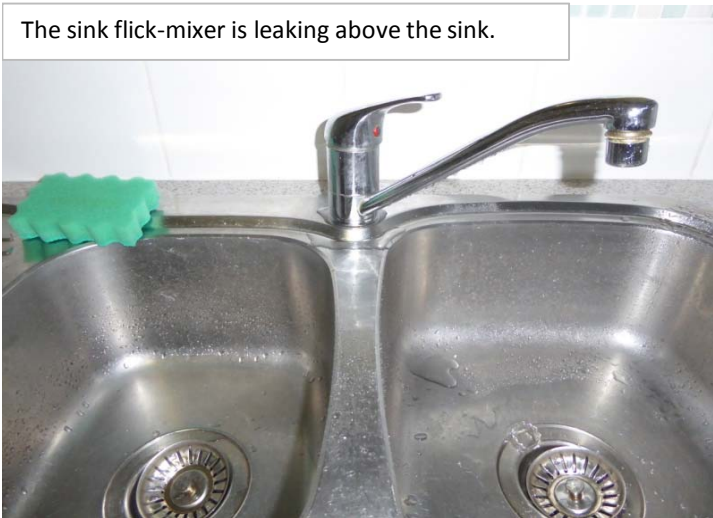
The sink flick-mixer is leaking above the sink.

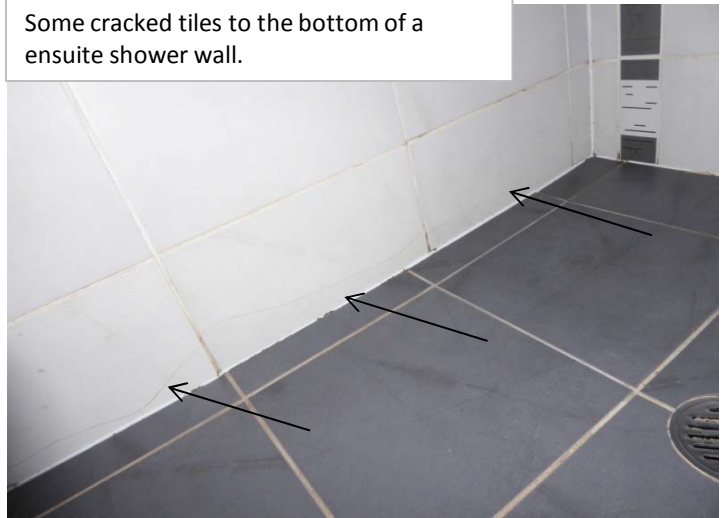
Ensuite	
Doors	✓
Windows, SGD	✓
Walls & Ceiling	A poorly carried out repair to the wall beside the shower.
Bath, Shower	A drummy tile to the shower floor. <i>Some cracked tiles to the bottom of a shower wall. The shower cubicle will need renovation work. It is recommended that a licensed plumber and licensed tiler-waterproofer inspect the shower/bath cubicle, report on the scope of work required to repair or rectify the defects and quote a price for this work.</i>
Vanity or Basin	✓
Shower screen	✓
Toilet	✓
Bedroom 2	
Doors	✓
Windows, SGD	✓
Walls & Ceiling	A small amount of cracking to the cornice.
Wardrobe	A small amount of damage to the bottom wardrobe shelf.
Bedroom 3	
Doors	✓
Windows, SGD	✓
Walls & Ceiling	✓
Wardrobe	✓
Bedroom 4	
Doors	✓
Windows, SGD	✓
Walls & Ceiling	✓
Wardrobe	N/A
Bedroom 5	
Doors	
Windows, SGD	
Walls & Ceiling	
Wardrobe

Some cracked tiles to the bottom of a ensuite shower wall.

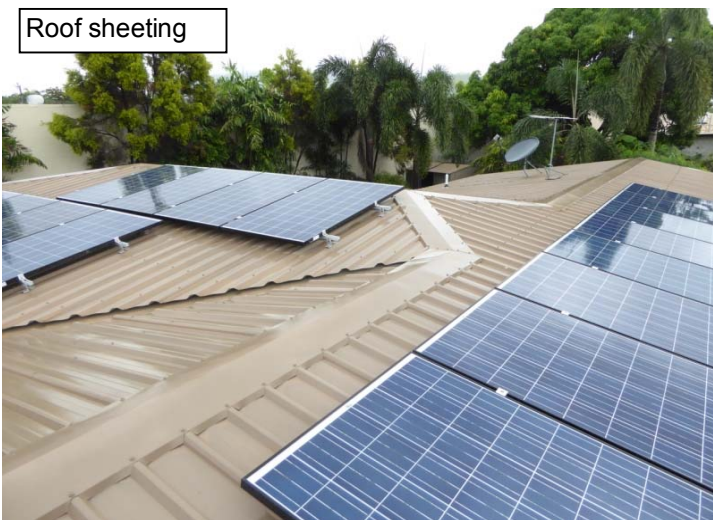
Roof sheeting

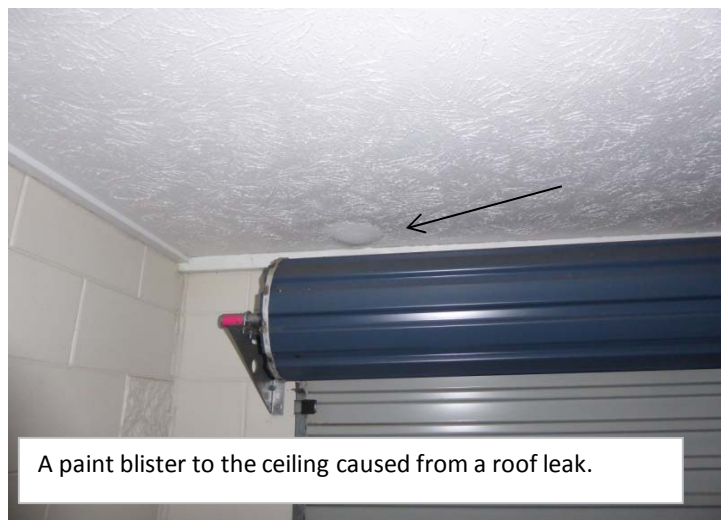
Bathroom	A partly drummy floor tile.
Doors	✓
Windows, SGD	✓
Walls & Ceiling	✓
Bath, Shower	A cross-threaded cold tap button.
Vanity or Basin	✓
Shower screen	✓
Toilet	
Doors	✓
Windows, SGD	✓
Walls & Ceiling	✓
Bowl & System	✓
Laundry	
Doors	N/A
Windows, SGD	N/A
Walls & Ceiling	✓
Laundry Tub	✓
Garage	
Doors	The exterior ply door is rubbing on the lock jamb.
Windows, SGD	✓
Walls & Ceiling	A small amount of peeling plasterboard tape and a small crack to the ceiling. A paint blister to the ceiling caused from a roof leak.
Roller Door Panel-Lift-Door	✓

A paint blister to the ceiling caused from a roof leak.

Roof , Valleys	The roof has been painted at some point in time. There is evidence of a roof leak to the garage ceiling. It is recommended that a licensed roof plumber inspect the roof and carry out necessary maintenance and repairs.
Guttering Down Pipes	A small number of small holes in the rear guttering are leaking and need resealing.
Eaves & Gablends	A small amount of rot and deterioration to the eaves and bottom of the R/H side gable end which need repairs and repainting. A loose eave cover strip to the L/H side to the rear of the garage.
Facias & Barges	✓

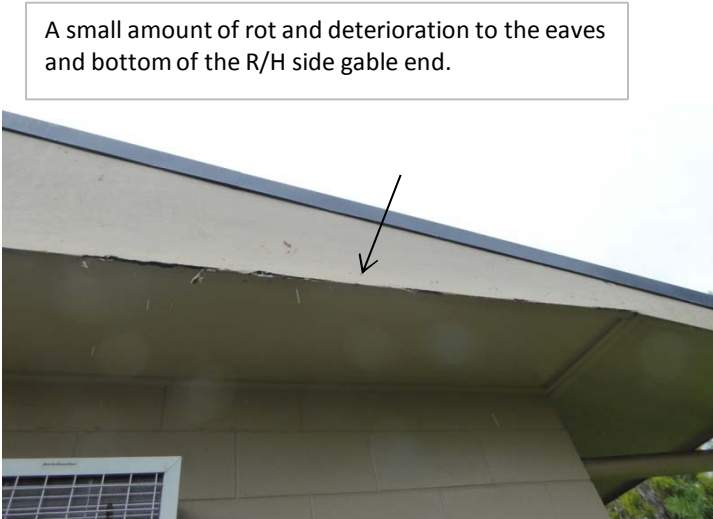
A small amount of rot and deterioration to the eaves and bottom of the R/H side gable end.

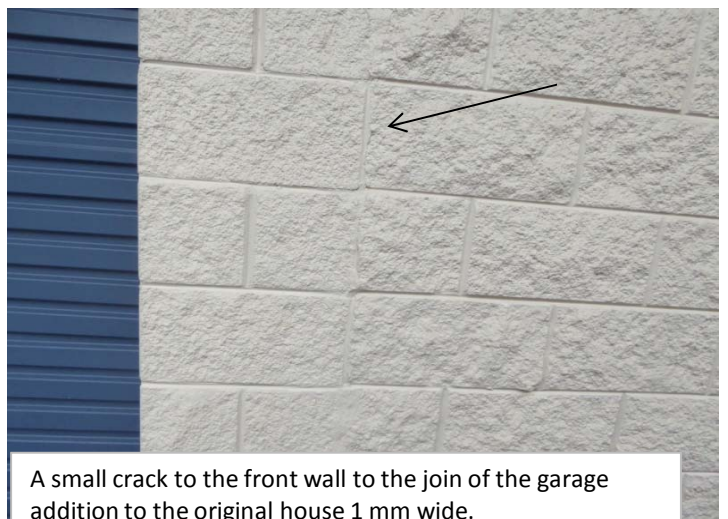
2.0 EXTERIOR OF THE BUILDING	
Walls	A small crack to the front wall to the join of the garage addition to the original house 1 mm wide. A small crack to the wall internal corner to the rear patio to the join of the rear addition to the original house less than 1mm wide.
Exterior Paint	The exterior wall cracks will need to be filled with acrylic or polyurethane based joint sealant filler to prevent moisture penetrating into the walls.
Doors	✓
Windows	✓
Veranda's, Patios, Decks,	✓
Window Sills	✓
Attached Structures	✓

A small crack to the front wall to the join of the garage addition to the original house 1 mm wide.
