## Pre-Purchase Inspection - Residential Building Report

Inspection Address: Hermit Park

**Date of Agreement:** 09-June-2017

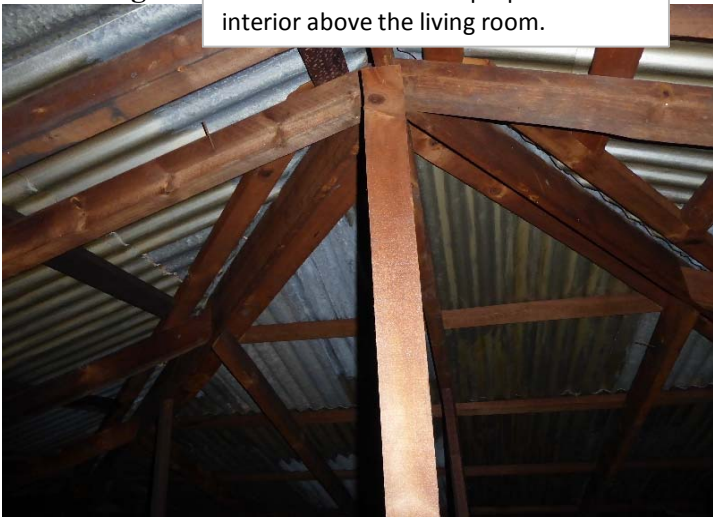
There is a loose timber prop to the roof interior above the living room.

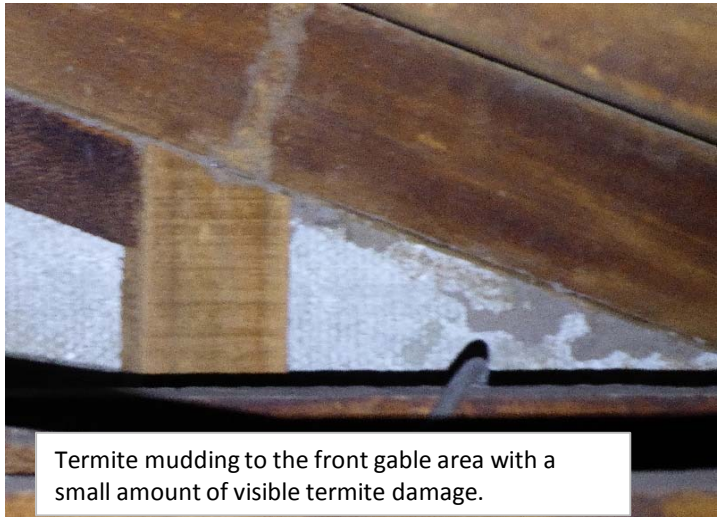
4. There is termite mudding to the ground floor area and to the roof cavity; this could result in concealed termite damage. To determine if there is concealed termite damage, the extent of any termite damage and the scope of work required to repair or rectify any damage, further invasive investigations are recommended.

Termite mudding to the front gable area with a small amount of visible termite damage.

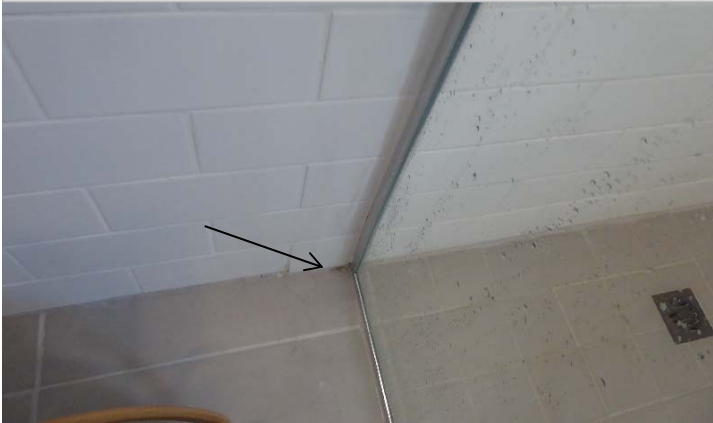
The shower is leaking beside the shower screen either from a leak through the shower wall tiles or a leak through the shower screen.

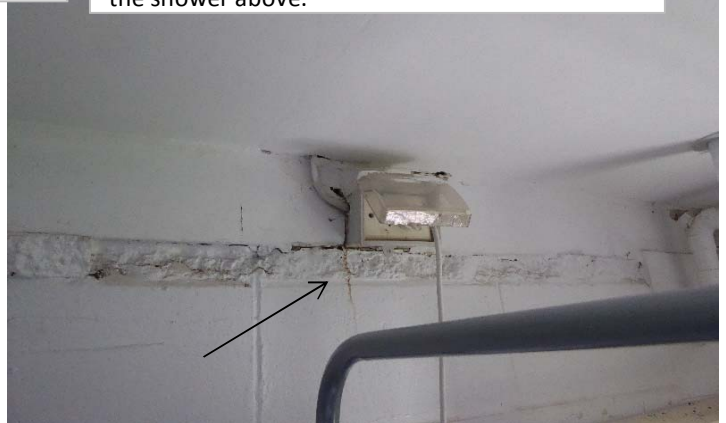
There is staining to the laundry wall under the bathroom which may be the result of a leak from the shower above.

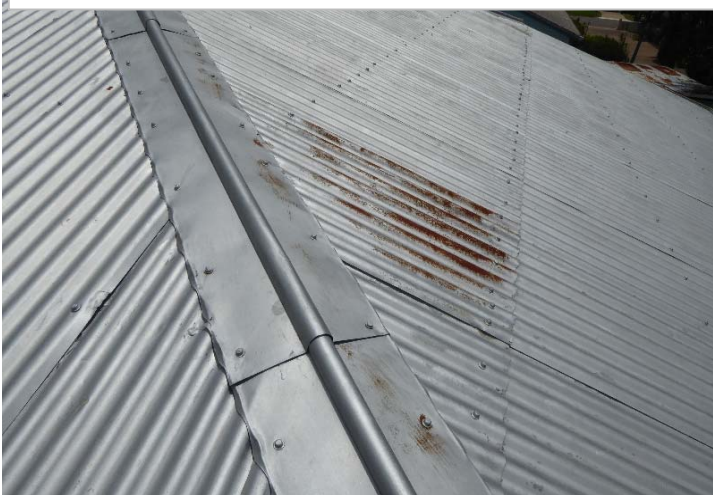
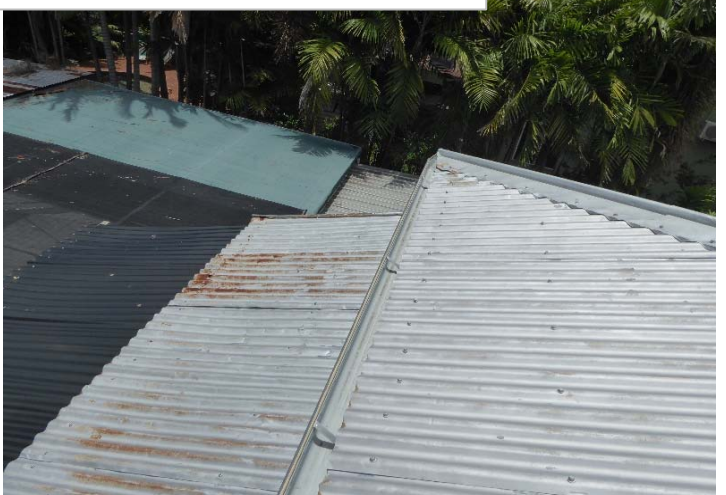
Roof , Valleys	<i>There is rust to the laps and ends of the roof sheets and loose lead head nails throughout the roof. Rust is starting to come through the roof paint and there is rust and dints to the rear lower roof. The roof will need restoration work or replacing. Restoration work will only prolong the life of the roof for a short time and then the roof will need replacing. It is recommended that a licensed roof plumber inspect the roof, report on the scope of work required to repair and rectify the defects and quote a price for this work.</i>
Guttering Down Pipes	✓
Eaves & Gablends	✓
Facias & Barges	✓

There is rust to the laps and ends of the roof sheets and loose lead head nails throughout the roof. Rust is starting to come through the roof paint and there is rust and dints to the rear lower roof.
