Pre-Purchase Inspection - Residential Building Report

Clients Name: Low Set Masonry Block Home

Inspection Address: Annandale

Date of the Inspection: 12-August-2017 **Time of Inspection:** 12:30:00 PM

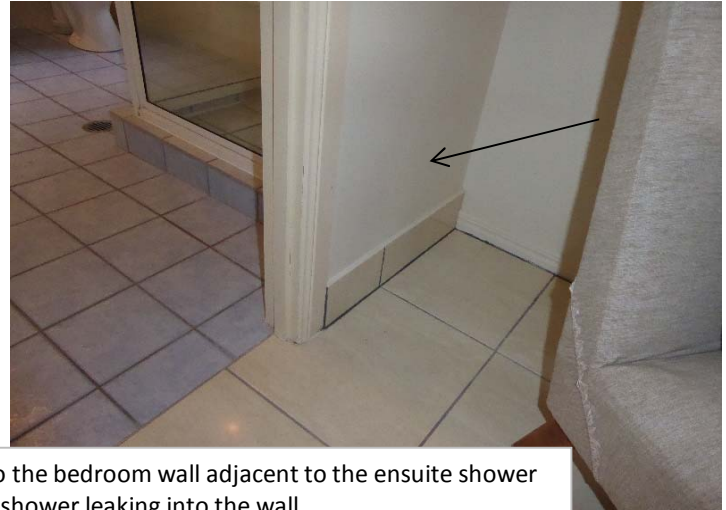
There is high moisture to the bedroom wall adjacent to the ensuite shower cubicle caused from the shower leaking into the wall.
