## Pre-Purchase Inspection - Residential Building Report

Inspection Address: Hermit Park

**Date of Agreement:** 09-June-2017

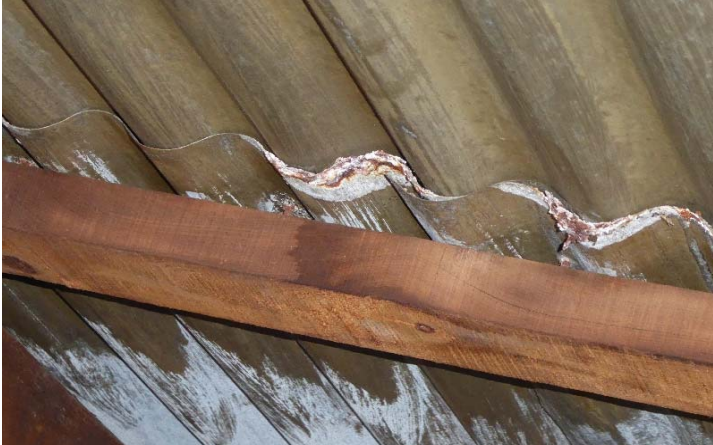
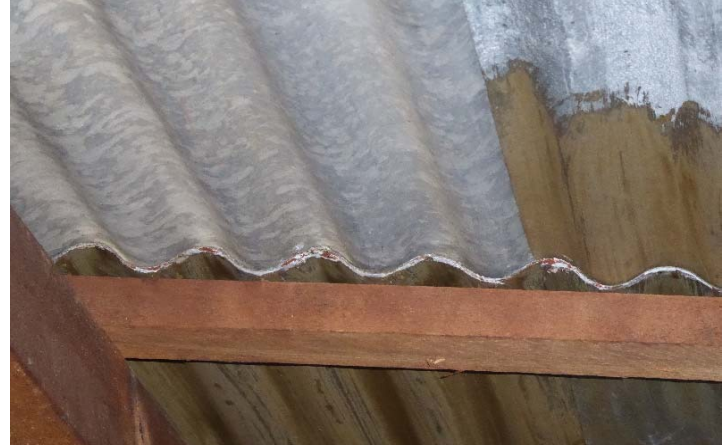
There is rust to the laps and ends of the roof sheets and loose lead head nails throughout the roof. Rust is starting to come through the roof paint and there is rust and dints to the rear lower roof.
